PERIODIC REVIEW

**Brundage Bone Concrete Pumping
Facility Site ID#: 2251**

**1041 North 4th Avenue,
Kent, Washington**

December 2009

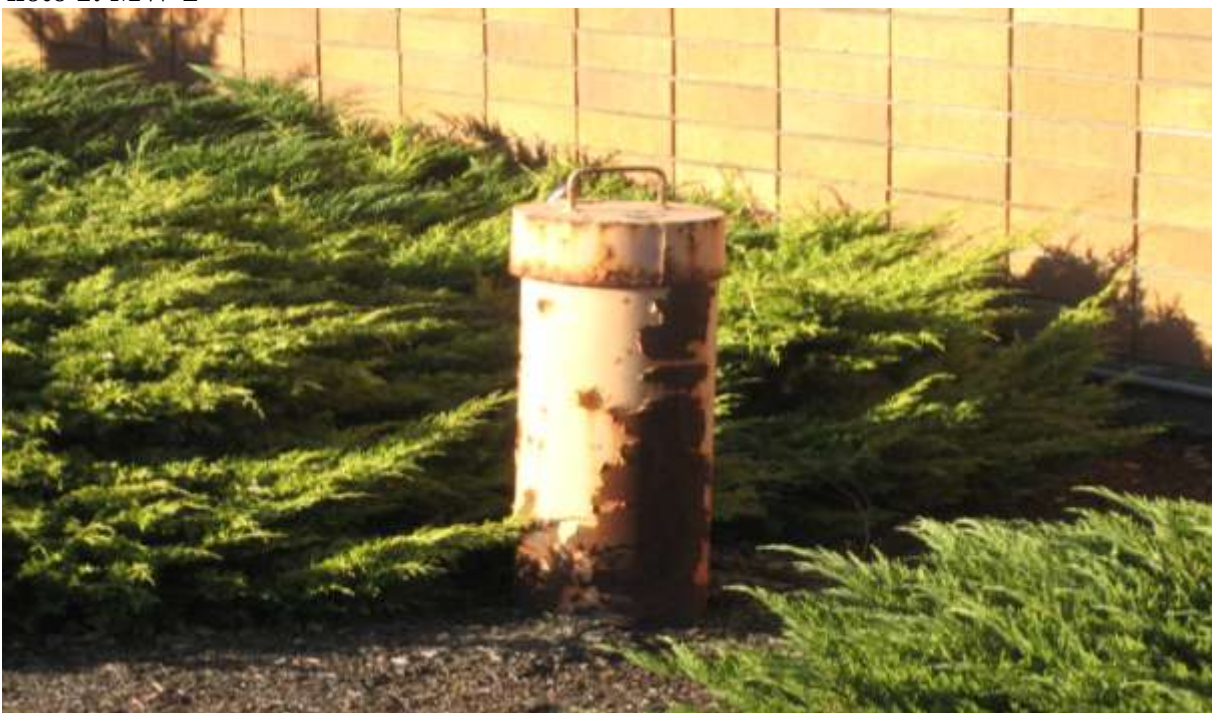
Photo 1: MW-2

There were vinyl chloride exceedances in the groundwater in MW-2 and it has not been established that the exceedances remain within the property boundary. That is necessary to establish a conditional point of compliance for groundwater among other requirements.

Based on this periodic review, the Department of Ecology has determined that the requirements of the Restrictive Covenant continue to be met. No additional cleanup actions are required by the property owner, except monitoring for vinyl chloride and establishment of a standard or conditional point of compliance are likely to be necessary for a full cleanup. It is the property owner's responsibility to continue to inspect the site to assure that the integrity of the remedy is maintained.

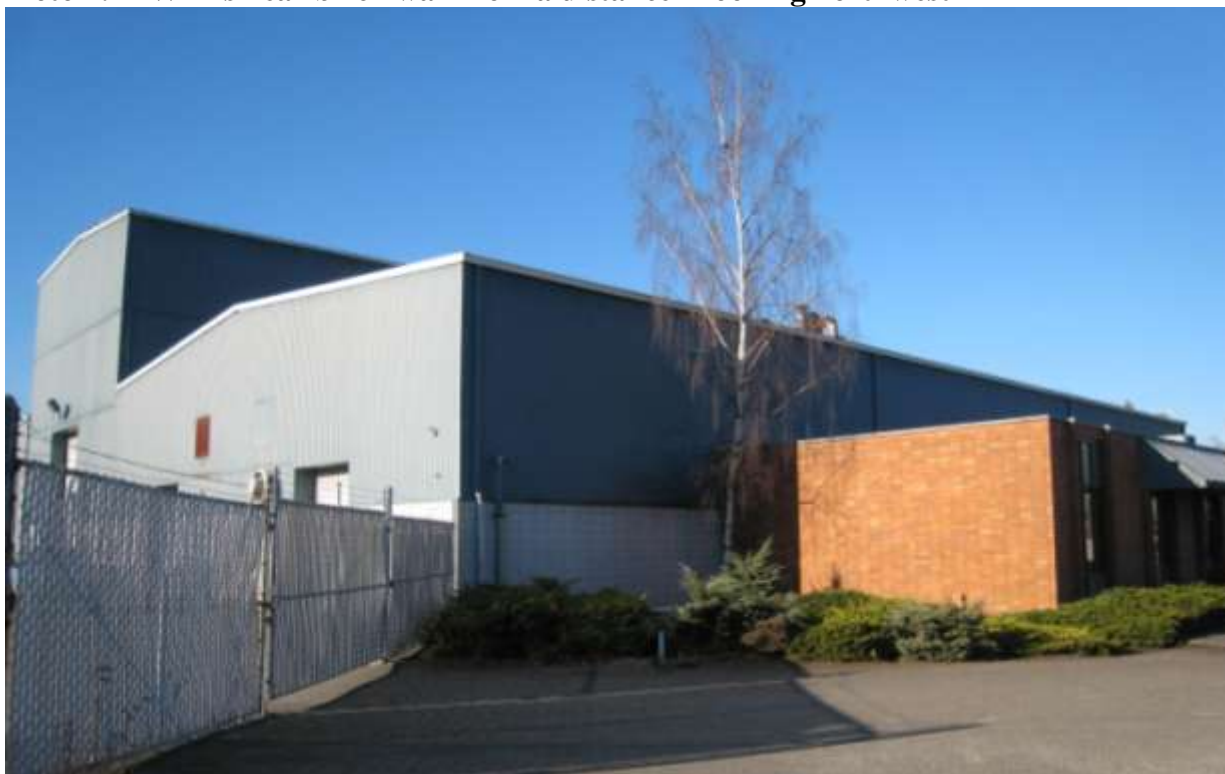
Photo 2: MW-2 is near brick wall from a distance – looking northwest

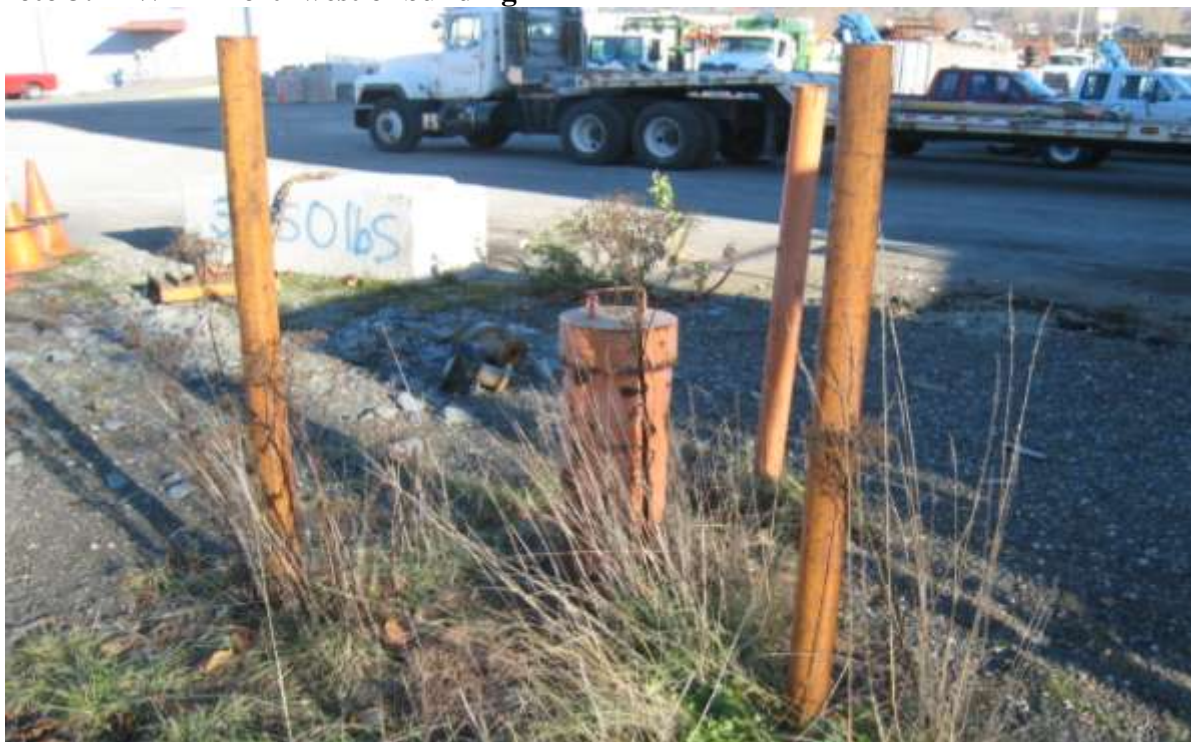
Photo 3: MW-1 – northwest of building

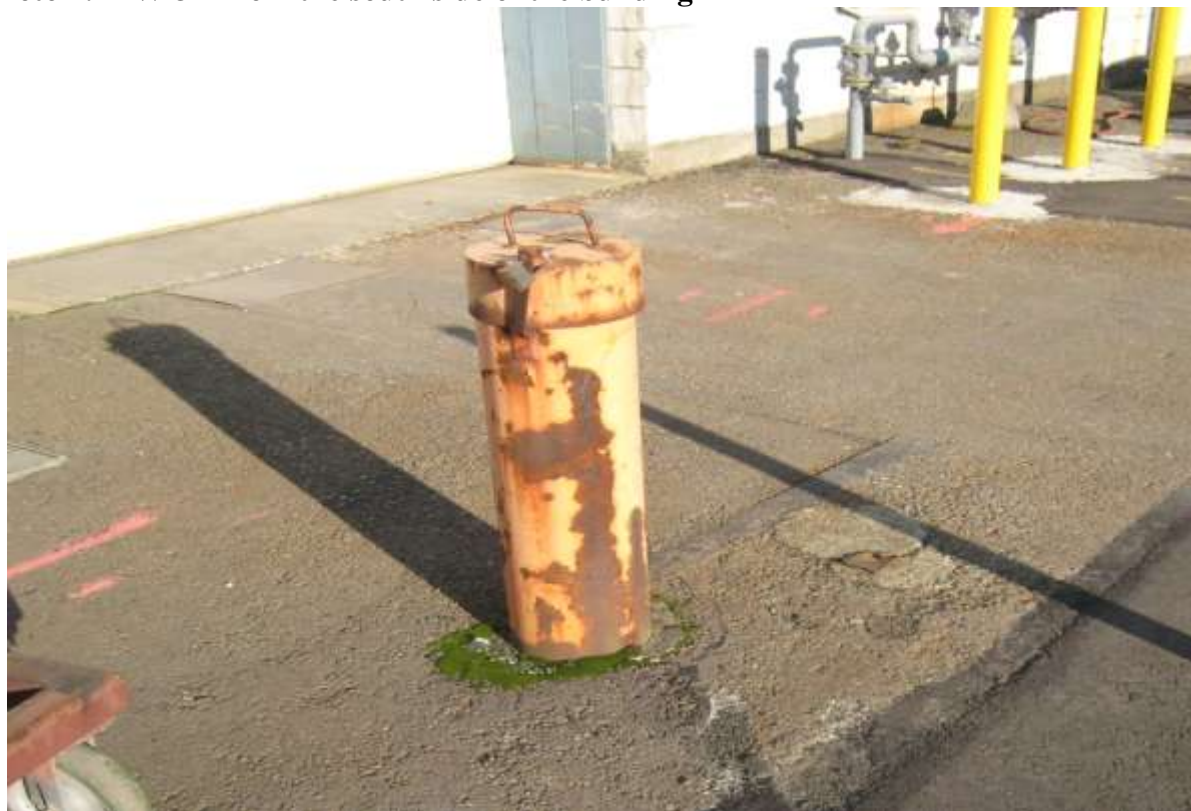
Photo 4: MW-3 – from the south side of the building
